Subject: Charge Pressure Bypass Valve, Noisy

Number: 00-01

Model(s): TT with 1.8L Turbo
(eng. codes ATC, AMU, AWP)

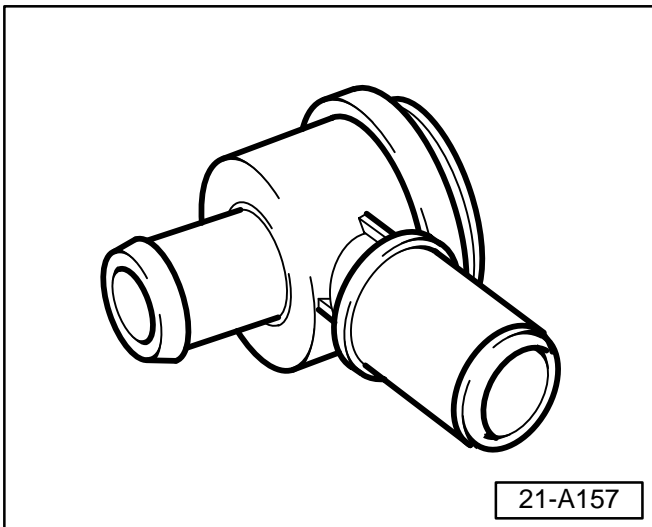
Groaning or howling noise from engine compartment when accelerating during partial load between 2500-3000 RPM.

Rattling noise when decelerating between 2000 - 3000 RPM.

May be caused by the Internal diaphragm of the Charge pressure bypass valve producing pulsating noises.

- Road test to verify condition.
- Remove upper engine cover.
- ◀ - Remove Charge pressure bypass valve.
- Install new Charge pressure bypass valve, Part no: 06A 145 710N.
- Install upper engine cover.
- Road test to verify condition has been eliminated.
